NATIONAL TRANSPORTATION SAFETY BOARD

TRANSPORTATION SAFETY RECOMMENDATIONS

**ADOPTED DURING THE MONTH
OF JULY, 1998**

In reply refer to: A-98-44 through -58

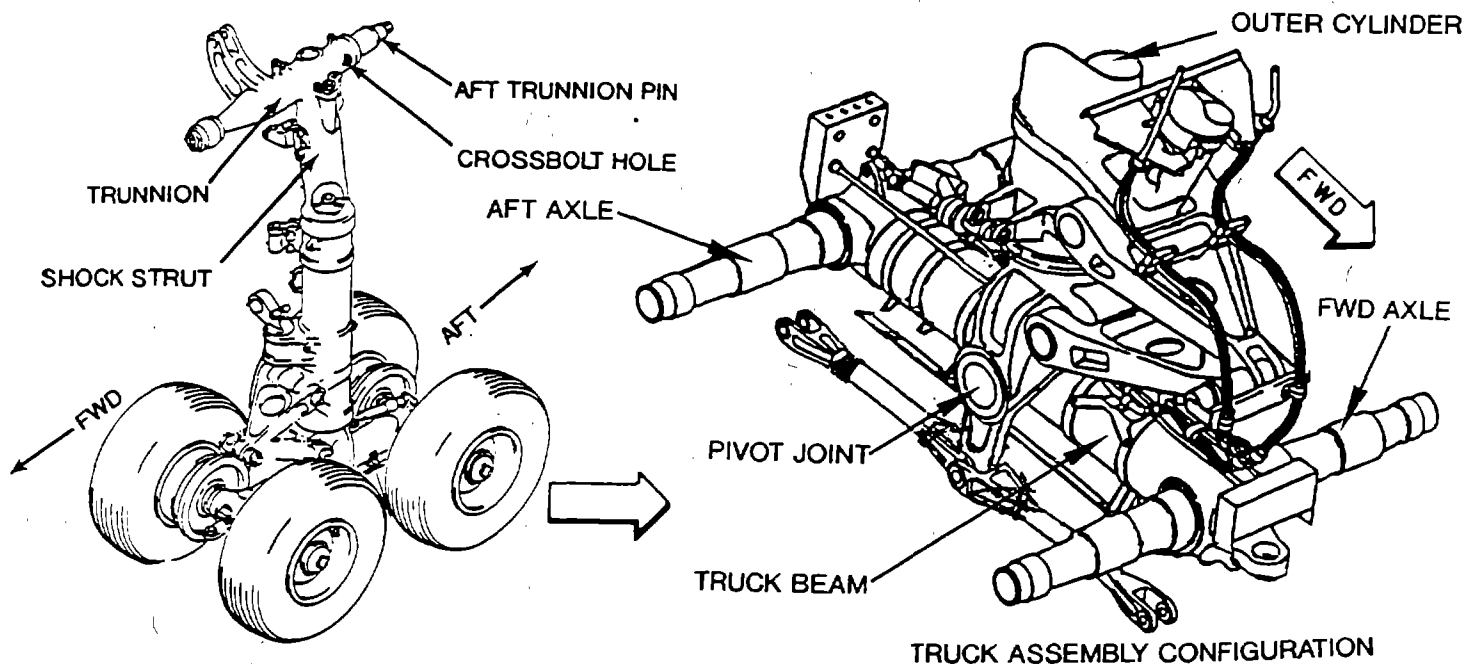
Figure 1. Boeing 757 Main Landing Gear Assembly

The 757 MLG is a conventional, four-wheel, dual-tandem landing gear that has a metering pin orifice shock strut (see figure 1). The gear has four support points: the forward trunnion, the aft trunnion, the drag brace, and the side strut. The shock strut outer cylinder of the MLG assembly transfers operational loads from the truck assembly to the four support points. The assembly consists of a truck beam, axles, wheels and tires, brake rods, and a protective shield. The truck beam is the primary supporting member of the truck assembly. It pivots on the lower end of the shock strut outer cylinder.

The Safety Board's materials laboratory examined the right MLG truck beam and found three anomalies: missing primer, missing CIC, and a plugged drainage opening. About 75 percent of the inner surface of the truck beam was missing CIC, exposing the primer. There were localized spots of corrosion and exposed bare metal where the primer was missing. The primer was missing primarily on the bottom inner surface of the truck beam. In this area, some remaining primer had bubbled up and could easily be scraped off. Both ends of the truck beam contained approximately 2-inch diameter globules of CIC and grease. These globules and a dirt/grease mixture had clogged the truck beam's drainage opening.

The examination of the fracture surfaces disclosed a 0.9-inch wide region that showed characteristics of SCC. The primer was missing on the inner surface of the truck beam in the SCC area. Scanning electron microscope examination of the 0.9-inch wide SCC fracture region disclosed intergranular features, typical of SCC in 4340M steel, that emanated from three corrosion pits on the inner diameter surface. These corrosion pits measured no more than 0.01 inch deep by 0.01 inch diameter. The rest of the fracture area exhibited river pattern features characteristic of overstress.

Examination of the left MLG of the incident airplane at the overhaul facility revealed large globules of grease and CIC clogging the truck beam drainage opening similar to that found in the right MLG. The CIC had separated from the inner surface and there were patches of corrosion and areas where the primer was missing. The surface corrosion on the inner surface of the left MLG truck beam was more extensive than that found on the right MLG.
